Phase II Results

Field to Stream Partnership

Phase II

JUNE 2022

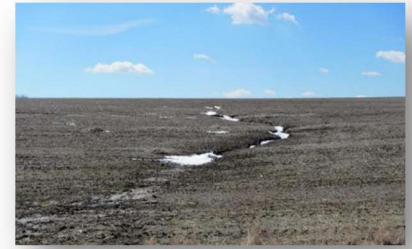
Ephemeral gully in a high runoff risk area in the bluffland landscape.

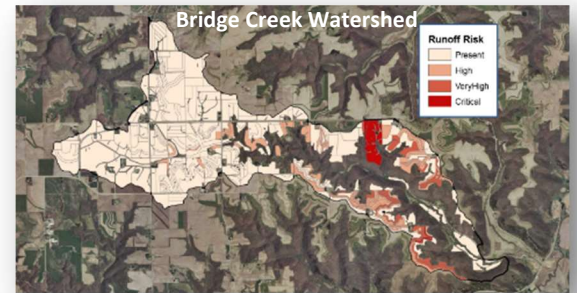
tools were used to identify and target sites with the greatest impact on water quality. For example, the dark red field in this map was identified as one of the highest runoff risk fields in the Bridge Creek watershed (critical runoff risk).

This field was recently converted to conservation reserve program (CRP) prairie grasses. New grassed waterways and water and sediment control structures were installed to make the field more resilient when converted back to cropland.

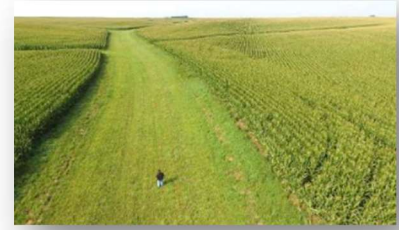
100,000+ feet of new and repaired grassed waterways

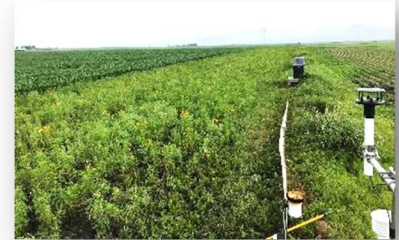
200+ acres of targeted perennials

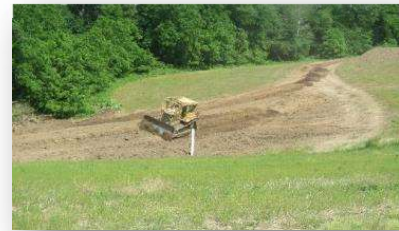
14 new water/sediment control basins

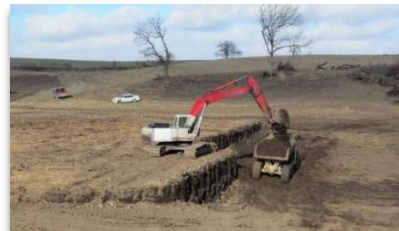
Sediment clean-out of 1950s era flood control structure (E3). Picture Nov. 2017.

Rehabilitation of a 1950s era flood control structure (E3) in the Crystal Creek Watershed. This one structure treats 45% of the watershed. Over 23,000 tons of stored sediment was removed from the pool area in 2017. This cost-effective project will extend the sediment and nutrient trapping benefits for an additional 50 years.

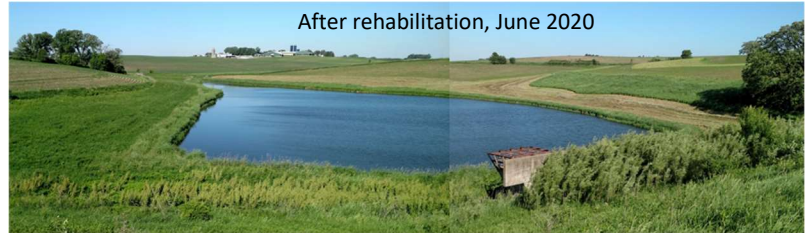
1956

2013

After rehabilitation, June 2020
