New Life for Old Flood Structure

Kevin Kuehner, Root River Field to Stream Partnership, August 2018

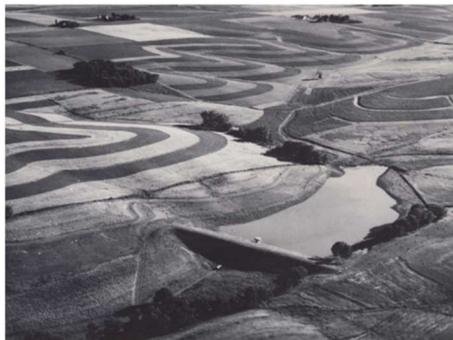
1956

The black and white picture above shows the E3 structure one year after construction in 1955. The adjacent picture, taken fifty-seven years later, shows the four-acre pool area filled with topsoil. This sediment reduced the capacity of this structure to trap additional sediment and nutrients.

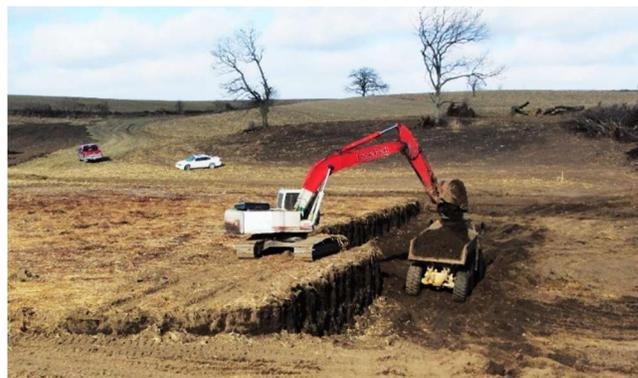
This picture taken in early December of 2017 shows the excavation of nearly 60 years of topsoil, up to nine feet deep, within the structure pool area.

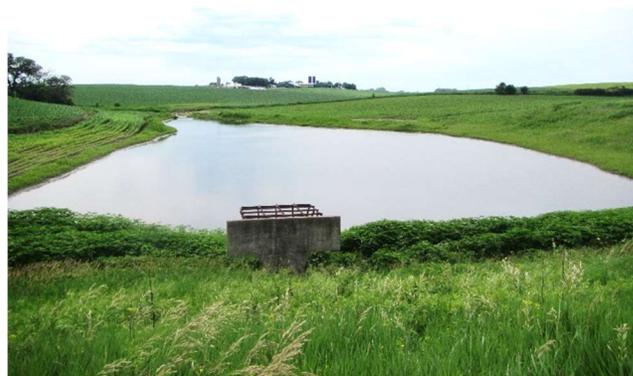
Slow release of water after a heavy June rainfall on June 28, 2018. Picture was taken seven months after the sediment clean-out project.
