New Life for Old Flood Structure

Kevin Kuehner, Root River Field to Stream Partnership, Aug. 2018

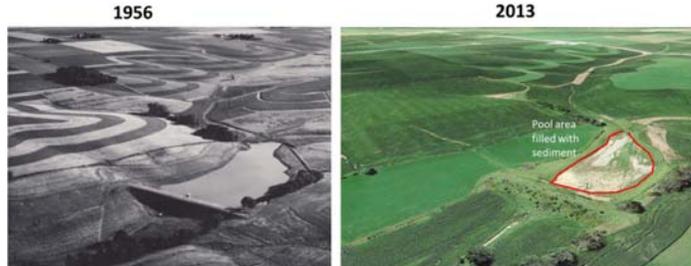
The black and white picture above shows the E3 structure one year after construction in 1955. The adjacent picture was taken fifty-seven years later and shows the four-acre pool area filled with topsoil and much less capacity to trap additional sediment and nutrients.

Over the past sixty years, topsoil loss from the upper half of watershed has displaced the pool area. This has had little effect on diminishing the flood-control benefits, but has significantly reduced sediment and nutrient trapping efficiency from an estimated 80% to 20%. With the project complete, the efficiency has been restored back to its original design and its roughly estimated that an additional 144 tons of soil, 1,152 pounds of nitrogen, and 288 pounds of phosphorus will be stored on an annual basis¹. Sediment surveys will be conducted in the pool area on a routine basis to quantify actual sediment delivery rates and trapping efficiency.

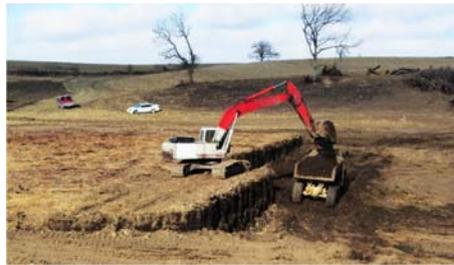
This picture taken in early December of 2017 shows the excavation of nearly 60 years of top soil, up to nine feet deep, within the structure pool area.

New life has been restored to a 1950's era flood retention structure (E3) in the Crystal Creek watershed. Utilizing funding from a targeted watershed grant by BWSR and technical assistance from the SE Technical JPB and Fillmore SWCD, 20,000 cubic yards (28,000 tons) of stored sediment was removed during a three-week period in December 2017. The project is expected to extend the sediment trapping benefits for an additional 30-50 years. To enhance upland treatment and prolong the benefits of the clean out, 25,000 feet of new and repaired grass waterways were installed by watershed farmers. A sentence to serve crew from Preston helped remove over-grown brush and small trees from the earthen dike as well.

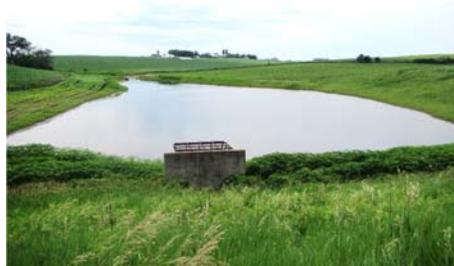
This picture was taken after the clean out on June 28, 2018. The structure slowly released water after a heavy rainfall.
